Case Study Using the Adapt Barrier Ring for Stomal Bridges/Rods

Overview

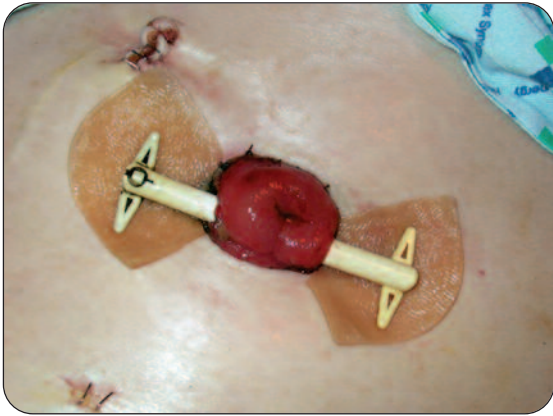
The prongs/'T' bars are cushioned by a hydrocolloid dressing.

A thin layer of hydrocolloid dressing was applied where the prongs/'T' bars from the bridge/rod made contact with the peristomal skin. This acted as a cushion.

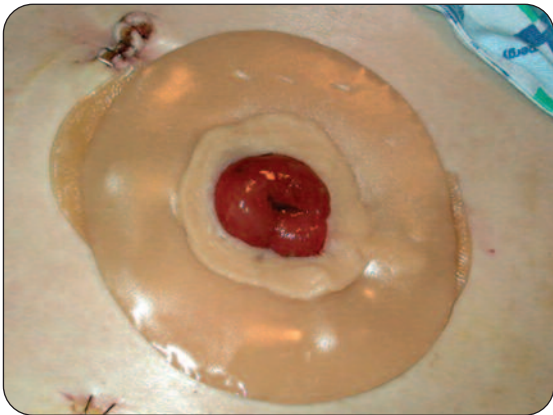
The bridge/rod is occluded by an Adapt Barrier Ring, and Adapt Paste applied around the stoma.

The entire bridge/rod was then draped with a Hollister **Adapt** Barrier Ring (occluding the bridge completely) and **Adapt** Paste was applied around the stoma. This allowed the Hollister **Moderma Flex** One-piece Drainable Pouch to be snugly applied over the Adapt Barrier Ring, increasing total wear time of the ring, paste, and pouch to 3-4 days.
