# A Ring is Not Just a Ring: Creative Uses of Ostomy Accessories

Juliet Smith, RN, BSN, CWOCN and Chenel Trevellini, RN, BSN, CWOCN

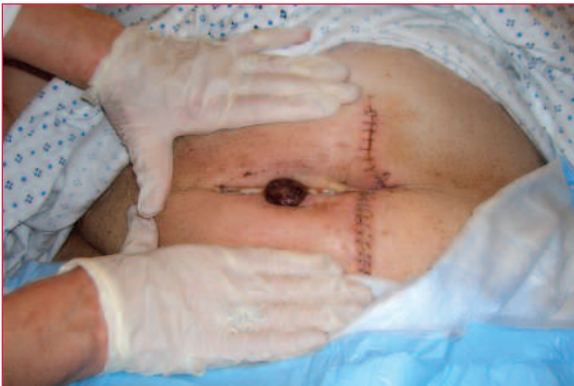
One week post-discharge, his midline incision opened vertically approximately three inches and to depth of one inch very near the stoma. His wife learned to pack the wound with a calcium alginate, and pouch wear time was preserved with no leaks. Although the stoma was initially very dark, it “pinked up” within two weeks and remained viable until the ostomy reversal procedure.

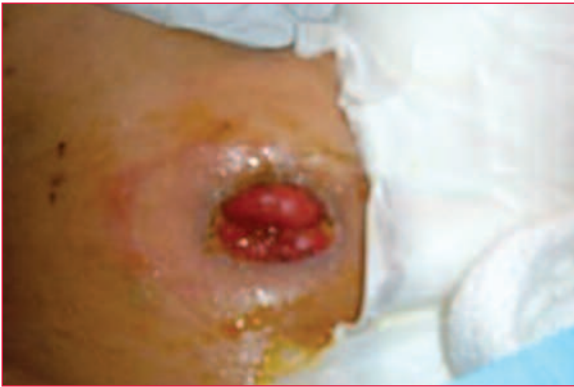
**Positive Outcomes:** The use of a **New Image Convex Skin Barrier**, along with an Adapt Barrier Ring stretched to an oval shape, helped to ensure a good seal (Photos 2 and 3). The successful pouching prevented leakage and peristomal skin damage (Photos 4 and 5).

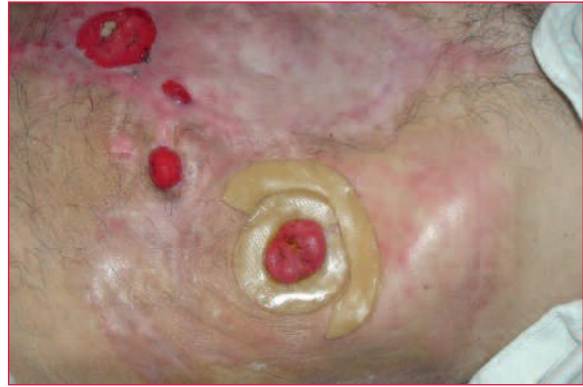
**Positive Outcomes:** After trying three or four different pouching systems, the WOC Nurse discovered that building up the peristomal skin with two to four Adapt Barrier Rings layered consecutively around each other expanded the adhesiveness of the foundation (Photo 1). This helped to increase the wear time to three to four days. The patient was able to snap on a high output pouch. He also used pieces of the Adapt Barrier Ring as a dam between the abdominal fistula and the tape on the skin barrier of the pouching system to enhance the seal (Photo 2).

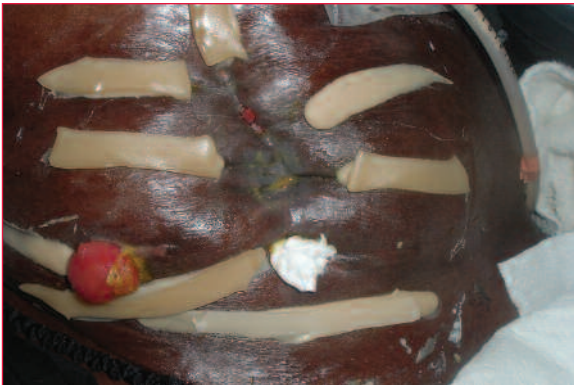
This patient was delighted and so grateful that her new "foundation" for the pouch application was so dependable. She further said that it has given her "life back," knowing that her abdomen will stay dry and the seal of her pouch will stay intact for four days or longer due to the creative use of those "sticky" Adapt Barrier Rings.

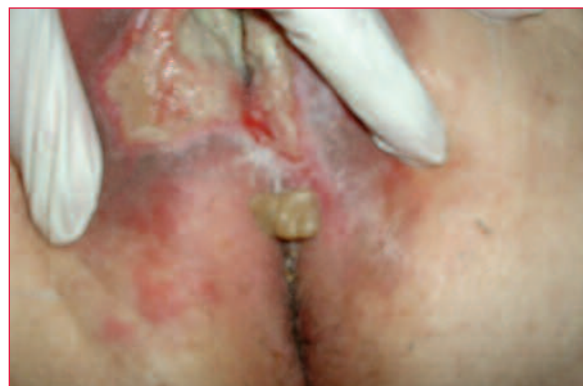
**Positive Outcomes:** An Adapt Barrier Ring was utilized in conjunction with the NPWT dressing and an immediate secure seal was achieved (Photo 1). The wound site demonstrated progress. However, after several dressing changes, the patient was unable to tolerate the NPWT and treatment was changed. The use of the Adapt Barrier Ring allowed the NPWT dressing to be changed every 72 hours and maintained a satisfactory seal without the need for more nursing visits for dressing leaks.

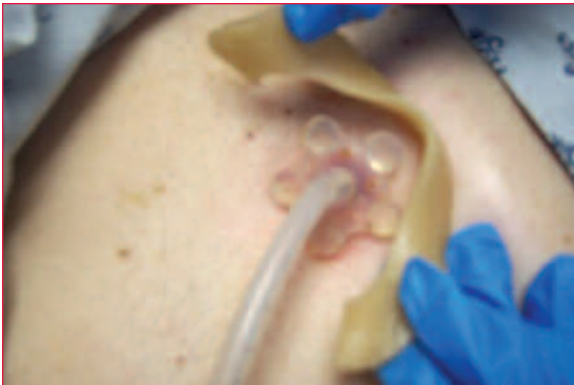
**Positive Outcomes:** An Adapt Barrier Ring was flattened and utilized around the base of the G-tube. This helped to prevent skin erosion from the projections underneath the bumper plate. The addition of the Adapt Barrier Ring also stabilized the tube and prevented leakage. (Photos 1 and 2)

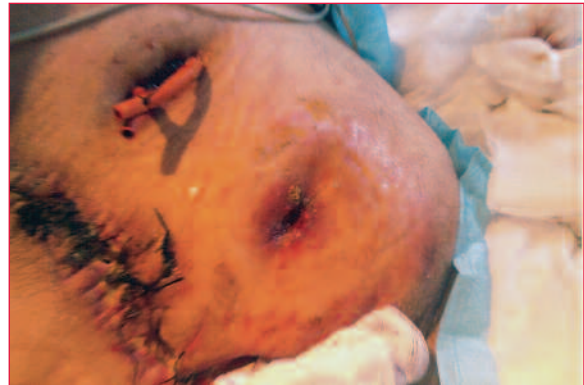
**Positive Outcomes:** Creative use of the Adapt Barrier Ring and a New Image Convex Skin Barrier for the loop colostomy helped to protect the skin and maintain a secure seal (Photos 2 and 3). With the aid of convexity and the Adapt Barrier Rings, success in preventing leakage from the high output ileostomy was achieved (Photos 4 and 5).
